**Flood Control Project Maintenance
Levee Inspections**
LMA District Cover Sheet
Spring 2018 Levee Inspection Results

Reclamation District No. 0150 Merrit Island

Spring 2018 Levee Inspection Results

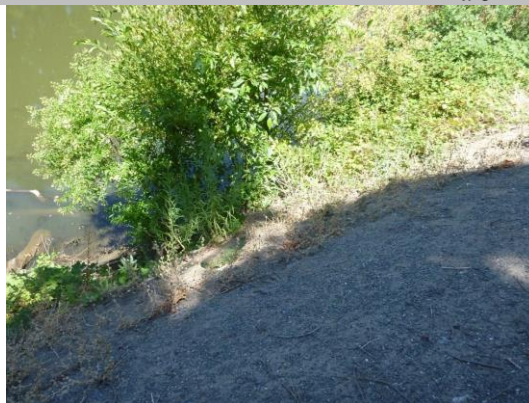
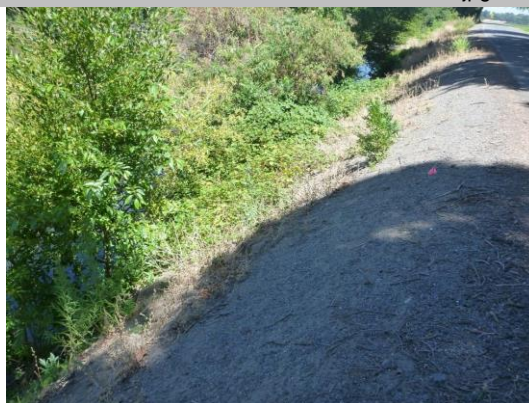
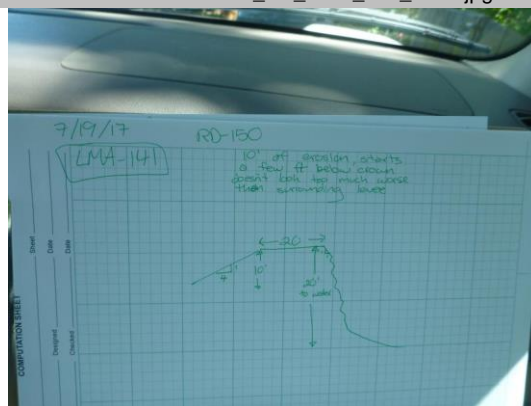
Description: Erosion was observed on the waterside levee slope on the east (left) bank of Elk Slough. The site is approximately 10 feet long and progresses up to the levee crown. See attached pages for photos.

LM Start	6.95	Rating **	A/W	Issue No.	121 (cont)
LM End	6.95	Issue Type +	Ma	Location *	
Category	Supplemental		GPS Latitude/Longitude		
			Start	End	
Item	2017 Storm Damage		38.397197°	38.397225°	
			-121.535089°	-121.535092°	
DWR ID	DWR_RD0150_03_f_2017_121				
Comment Code					
Inspector Comment					
<p>Levee Evaluation Comments</p> <p>Description: Erosion was observed on the waterside levee slope on the east (left) bank of Elk Slough. The site is approximately 10 feet long and progresses up to the levee crown. See attached pages for photos.</p> <p>Site ID No: 314</p> <p>Site Designation: LMA-141</p> <p>Repair Type: Erosion</p> <p>Rating: Area of Concern</p> <p>Field Date: 7/19/2017</p> <p>Notes: Area of concern because the site is so small and only looks slightly worse than the surrounding levee slope. Crown is a paved road.</p>

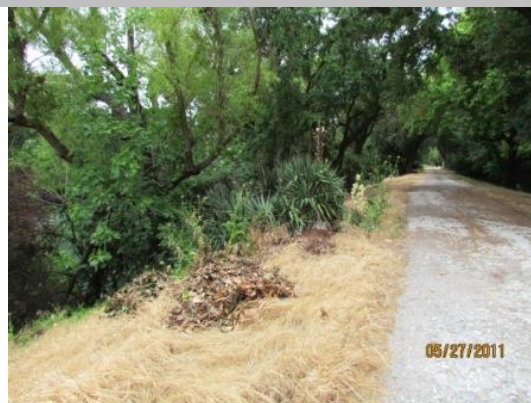
Photo 1 of 1 : SP_2018_RD0150_17_64_20180301_00061.jpg

LM Start	7.26	Rating **	U	Issue No.	64
LM End	7.26	Issue Type +	En	Location *	WS
Category	Earthen Levee		GPS Latitude/Longitude		
			Start	End	
Item	Vegetation		38.401481°	38.401481°	
			-121.536876°	-121.536876°	
DWR ID	DWR_RD0150_03_s_2012_64				
Comment Code					
V6 : Landscaping					
Inspector Comment

Landscaping on the waterside of the levee. The picture was taken from the crown looking upstream.

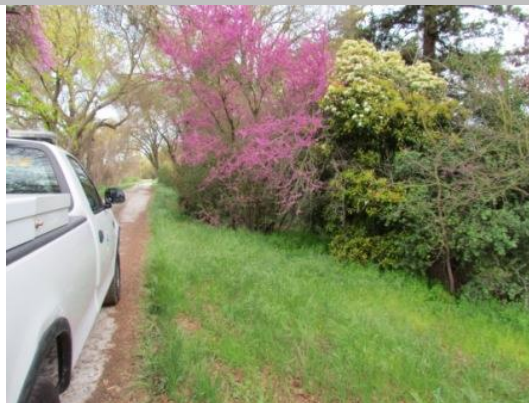
Photo 1 of 2 : SP_2018_RD0150_17_32_20180301_00015.jpg

LM Start	7.29	Rating **	U	Issue No.	32
LM End	7.34	Issue Type +	En	Location *	LS
Category	Earthen Levee			GPS Latitude/Longitude	
				Start	End
Item	Vegetation			38.401738 °	38.402296 °
				-121.537127 °	-121.537678 °
DWR ID	DWR_RD0150_03_s_2012_32				
Comment Code					
V6 : Landscaping					
Inspector Comment

Vegetation on the landside of the levee looking upstream. This picture was taken during spring 2012 inspection.

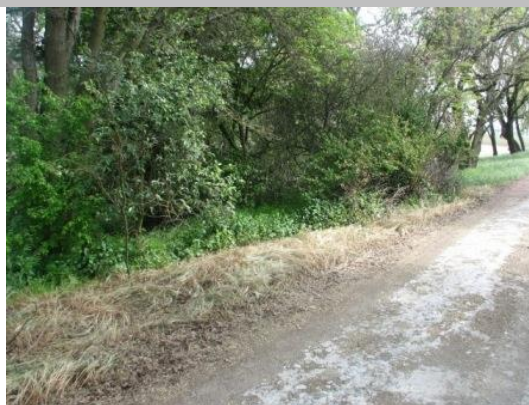
Photo 2 of 2 : SP_2018_RD0150_17_32_20180301_00016.jpg

Landscaping on landward slope blocking view from LM 7.42 to 7.47

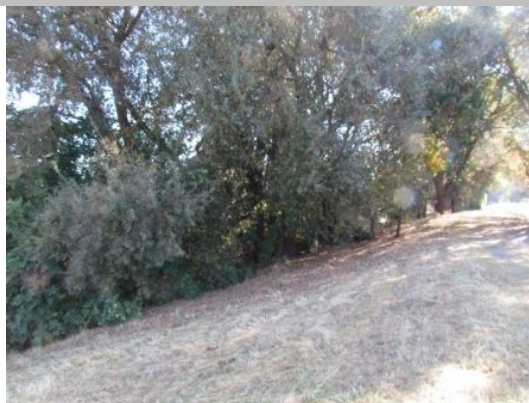
Photo 1 of 1 : SP_2018_RD0150_17_934_20180301_00150.jpg

LM Start	7.44	Rating **	U	Issue No.	934
LM End	7.44	Issue Type +	En	Location *	LS
Category	Earthen Levee			GPS Latitude/Longitude	
				Start	End
Item	Vegetation			38.403566 °	38.403566 °
				-121.538886 °	-121.538886 °
DWR ID	DWR_RD0150_03_s_2012_934				
Comment Code					
V6 : Landscaping					
Inspector Comment

Landscaping was blocking the visibility on the landside of the levee looking downstream.

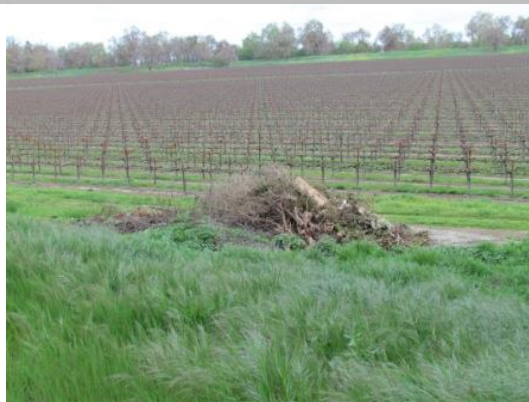
Photo 1 of 2 : SP_2018_RD0150_17_935_20180301_00151.jpg

LM Start	7.47	Rating **	M	Issue No.	935
LM End	7.47	Issue Type +	En	Location *	LS
Category	Earthen Levee			GPS Latitude/Longitude	
				Start	End
Item	Encroachments			38.403795 °	38.403795 °
				-121.539205 °	-121.539205 °
DWR ID	DWR_RD0150_03_s_2012_935				
Comment Code					
PR : Prunings					
Inspector Comment

Prunings were found on the landside of the levee looking upstream.

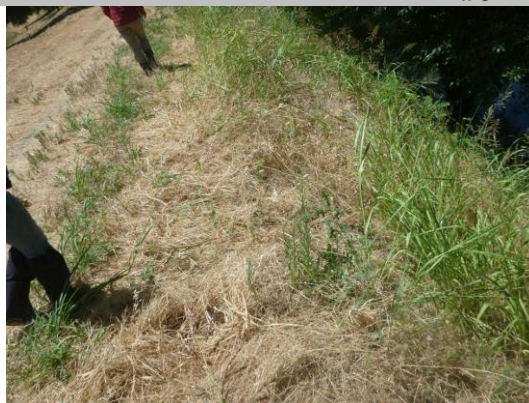
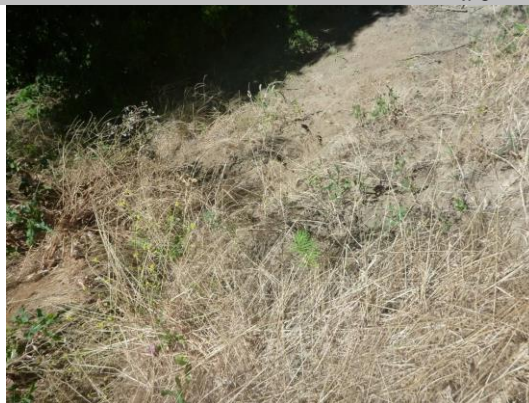
LM Start	8.05	Rating **	A/W	Issue No.	122
LM End	8.05	Issue Type +	Ma	Location *	
Category	Supplemental			GPS Latitude/Longitude	
				Start	End
Item	2017 Storm Damage			38.409228 °	38.409233 °
				-121.539389 °	-121.539356 °
DWR ID	DWR_RD0150_03_f_2017_122				
Comment Code					
Inspector Comment					
Levee Evaluation Comments					
Description:Erosion was observed on the waterside levee slope on the east (left) bank of Elk Slough. The site is approximately 10 feet long and progresses up to the levee crown. See attached pages for photos.					
Site ID No:315					
Site Designation:LMA-142					
Repair Type: Erosion					
Rating:Serious					
Field Date:7/17/2017					
Notes: The erosion extends along most of the slope. Nearby WS banks are all very steep (1:1 or less). Serious because the erosion extend along the entire slope, but not into the crown.

Item	2017 Storm Damage		38.409228°	38.409233°								
			-121.539389°	-121.539356°								
DWR ID	DWR_RD0150_03_f_2017_122											
Comment Code												
Inspector Comment												
<p>Levee Evaluation Comments</p> <p>Description: Erosion was observed on the waterside levee slope on the east (left) bank of Elk Slough. The site is approximately 10 feet long and progresses up to the levee crown. See attached pages for photos.</p> <p>Site ID No: 315</p> <p>Site Designation: LMA-142</p> <p>Repair Type: Erosion</p> <p>Rating: Serious</p> <p>Field Date: 7/17/2017</p> <p>Notes: The erosion extends along most of the slope. Nearby WS banks are all very steep (1:1 or less). Serious because the erosion extends along the entire slope, but not into the crown.</p>

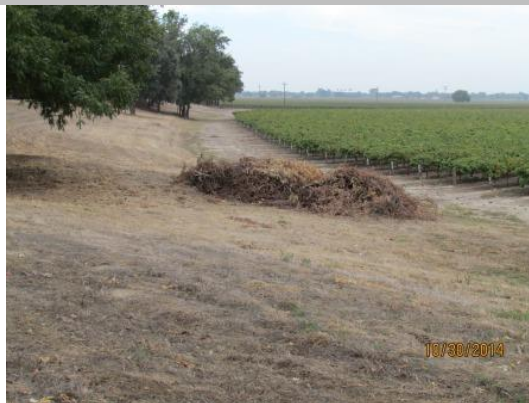
Photo 1 of 1 : SP_2018_RD0150_17_82_20180301_00082.jpg

LM Start	8.05	Rating **	M	Issue No.	82
LM End	8.05	Issue Type +	En	Location *	LS
Category	Earthen Levee			GPS Latitude/Longitude	
				Start	End
Item	Encroachments			38.409224 °	38.409224 °
				-121.539350 °	-121.539350 °
DWR ID	DWR_RD0150_03_f_2013_82				
Comment Code					
PR : Prunings					
Inspector Comment

Prunings were found on the landside toe of the levee looking upstream.

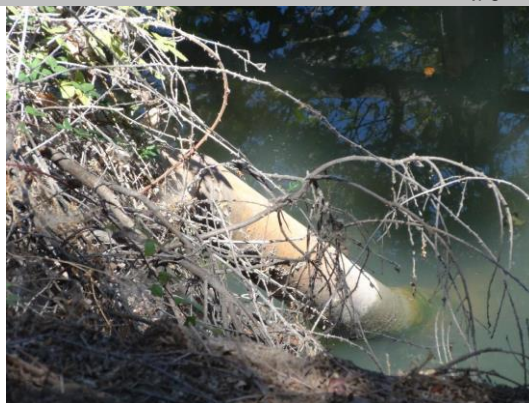
Photo 1 of 3 : UCIP_SP_2018_50670_33627.jpg

LM Start	8.20	Rating **	U	Issue No.	963	
LM End	8.20	Issue Type +	En	Location *		
Category	Supplemental			GPS Latitude/Longitude		
				Start	End	
Item	DWR UCIP Field Study			38.408619 °	38.408619 °	
				-121.536768 °	-121.536768 °	
DWR ID

Comment Code						
Inspector Comment						
FS_ID:50670 DS_ID:22466 EP_NO: N/A Repair Type: Urgent Crossing Status: Found UCIP Comments: 07/08/2016: Needs proper abandonment. Levee caved in below pipe at gate valve on WS. Discussed abandonment with Warren Bogle of Colby Ranch. (K. Fazel - UCIP)08/23/2013: Needs proper abandonment (P. Amatya - DWR) FIELD_STRUCT_DESC: *ABANDONED* 10-inch steel irrigation discharge pipe through the levee, invert elevation 13.8 feet below the crown. Gate valve on the waterside (WS) slope. Pilings in the stream, but no pump was found. Service pole with guy wire on the landside (LS) slope. Standpipe on the LS slope. (A. Colby). [Additional Reference(s): DWR Levee Log, 2005. USACE Sacramento O&M Manual 112, March 1957, (HLM 8.34)]. FS Date: 7/7/2016

WS view: pipe visible on levee slope and in the stream.

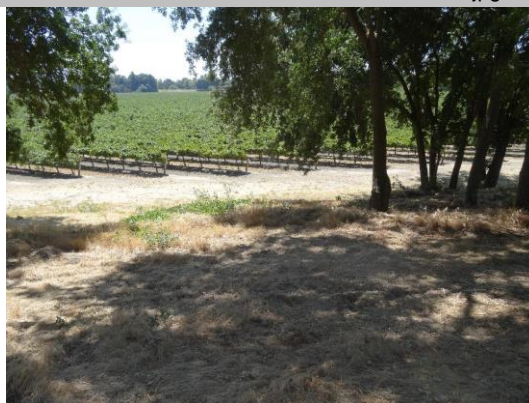
Photo 3 of 3 : UCIP_SP_2018_50670_33625.jpg

LS view: no pipe and structure found on landside.

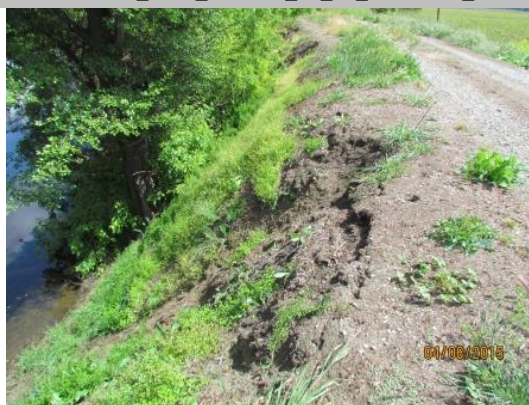
Photo 1 of 1 : SP_2018_RD0150_17_66_20180301_00063.jpg

LM Start	8.31	Rating **	M	Issue No.	66
LM End	8.31	Issue Type +	Ma	Location *	WS
Category	Earthen Levee			GPS Latitude/Longitude	
				Start	End
Item	Erosion / Bank Caving			38.407960 °	38.407960 °
				-121.534898 °	-121.534898 °
DWR ID	DWR_RD0150_03_s_2012_66				
Comment Code					
E2 : Schedule repair of erosion site prior to the next inspection.					
Inspector Comment

Updated picture of the erosion on the waterside of the levee.

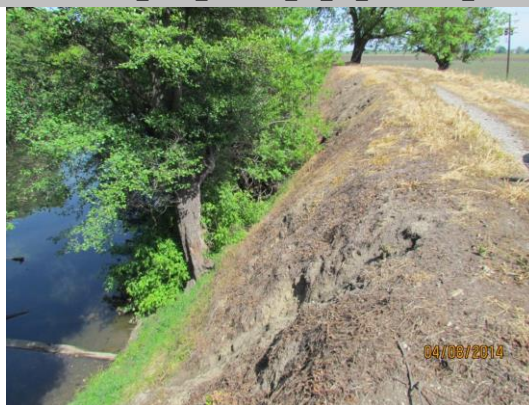
Photo 1 of 2 : SP_2018_RD0150_17_67_20180301_00064.jpg

LM Start	8.33	Rating **	M	Issue No.	67
LM End	8.33	Issue Type +	Ma	Location *	WS
Category	Earthen Levee			GPS Latitude/Longitude	
				Start	End
Item	Erosion / Bank Caving			38.407958 °	38.407958 °
				-121.534583 °	-121.534583 °
DWR ID	DWR_RD0150_03_s_2012_67				
Comment Code					
E1 : Note and monitor erosion site.					
Inspector Comment

Updated picture of the erosion on the waterside shoulder looking upstream during spring 2014 inspection.

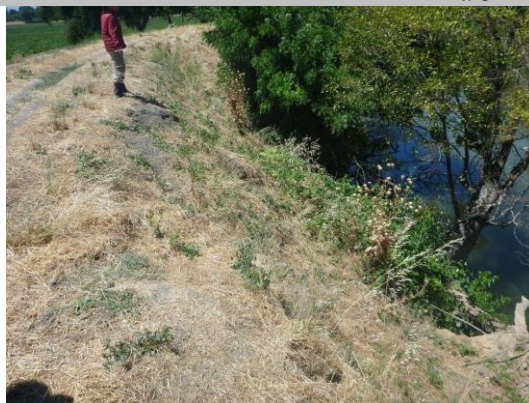
Photo 1 of 3 : LEVAL_SP_2018_316_2180.jpg

LM Start	8.35	Rating **	A/W	Issue No.	123
LM End	8.35	Issue Type +	Ma	Location *	
Category	Supplemental			GPS Latitude/Longitude	
				Start	End
Item	2017 Storm Damage			38.407983 °	38.407992 °
				-121.534322 °	-121.534289 °
DWR ID	DWR_RD0150_03_f_2017_123				
Comment Code					
Inspector Comment					
Levee Evaluation Comments					
Description:Erosion was observed on the waterside levee slope on the east (left) bank of Elk Slough. The site is approximately 10 feet long. See attached pages for photos.					
Site ID No:316					
Site Designation:LMA-143					
Repair Type: Erosion					
Rating:Serious					
Field Date:7/17/2017					
Notes: 3 large trees in/ajacent to site including a fallen tree in the middle of the erosion. Erosion on almost the whole slope, but doesn?t cut into the crown. Serious because erosion cuts into levee significantly here.

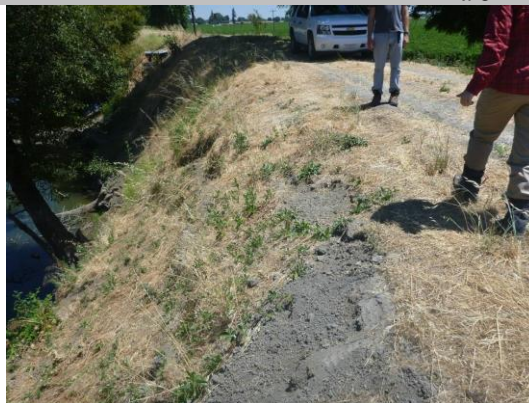
Photo 2 of 3 : LEVAL_SP_2018_316_2181.jpg

LM Start	8.35	Rating **	A/W	Issue No.	123 (cont)
LM End	8.35	Issue Type +	Ma	Location *	
Category	Supplemental		GPS Latitude/Longitude		
			Start	End	
Item	2017 Storm Damage		38.407983 °	38.407992 °	
			-121.534322 °	-121.534289 °	
DWR ID	DWR_RD0150_03_f_2017_123				
Comment Code					
Inspector Comment					
<p>Levee Evaluation Comments</p> <p>Description: Erosion was observed on the waterside levee slope on the east (left) bank of Elk Slough. The site is approximately 10 feet long. See attached pages for photos.</p> <p>Site ID No: 316</p> <p>Site Designation: LMA-143</p> <p>Repair Type: Erosion</p> <p>Rating: Serious</p> <p>Field Date: 7/17/2017</p> <p>Notes: 3 large trees in/adjacent to site including a fallen tree in the middle of the erosion. Erosion on almost the whole slope, but doesn't cut into the crown. Serious because erosion cuts into levee significantly here.</p>

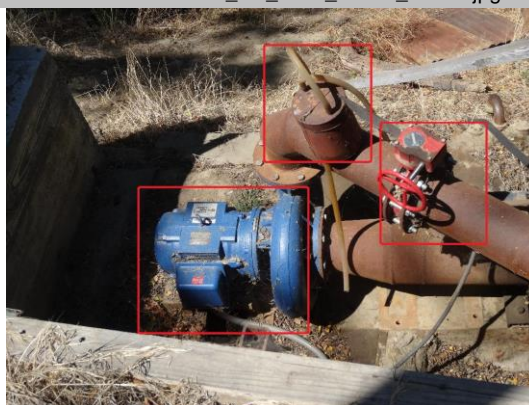
Photo 2 of 3 : UCIP_SP_2018_41648_33641.jpg

WS view: pump, gate valve, and airvent on pipe inside concrete masonry box.

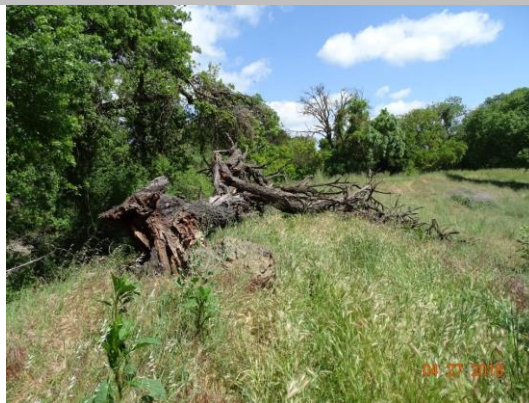
Photo 1 of 1 : SP_2018_RD0150_17_128_20180430_00201.jpg

LM Start	8.95	Rating **	U	Issue No.	128
LM End	8.95	Issue Type +	Ma	Location *	CR
Category	Earthen Levee			GPS Latitude/Longitude	
				Start	End
Item	Encroachments			38.414831 °	38.414831 °
				-121.528982 °	-121.528982 °
DWR ID	DWR_RD0150_03_s_2018_128				
Comment Code					
TR : Tree or limb					
Inspector Comment					
Downed tree blocking crown access.

Downed tree blocking crown looking north.

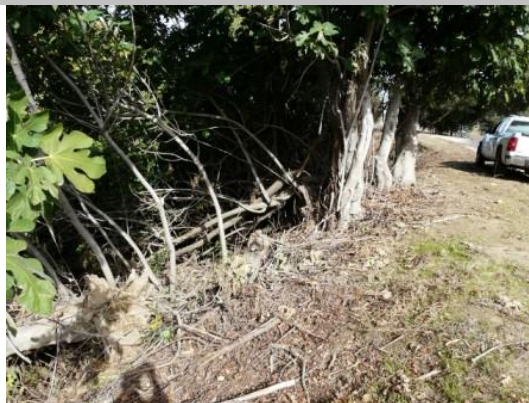
Photo 1 of 1 : SP_2018_RD0150_17_73_20180301_00070.jpg

LM Start	9.35	Rating **	U	Issue No.	73
LM End	9.35	Issue Type +	Ma	Location *	WS
Category	Earthen Levee			GPS Latitude/Longitude	
				Start	End
Item	Trim / Thin Trees			38.413169 °	38.413169 °
				-121.523707 °	-121.523707 °
DWR ID	DWR_RD0150_03_s_2012_73				
Comment Code					
T3 : Trim and thin trees to allow visibility of the ground and room to flood fight.					
Inspector Comment

Thin/trim trees to allow for visibility of top 20' of waterward slope.
